## BUILDING DATA

Approximate age 1970 Style SINGLE FAMILY Main entrance faces NW  
 Weather condition: Snow covered  Wet  Raining  Dry  Temperature 300

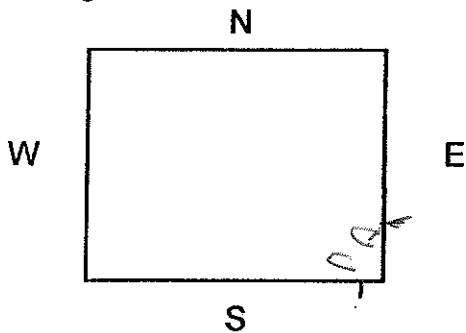
Access: INSIDE  OUTSIDE \_\_\_ Stairs: Sat.  Need support \_\_\_ Need baluster  Uneven risers \_\_\_  
 Handrail: Missing \_\_\_ Sat. \_\_\_ (Crawl space could not be fully viewed or accessed: \_\_\_ % Visible \_\_\_)  
 Foundation Walls: Poured concrete  Block \_\_\_ Stone \_\_\_ Brick \_\_\_ Insulated: NO  
 Unusual Cracks Apparent \_\_\_ Typical Cracks Apparent  Recommend evaluation by engineer: \_\_\_  
 Without a drain tile system, all or part of this basement / crawl space is susceptible to water seepage: \_\_\_  
 There are signs that this basement has flooded in the past: YES NO  Today it is dry: YES  NO

Floor: Concrete:  Dirt/gravel \_\_\_ Carpet/tile  Unusual Cracks Apparent \_\_\_ Condition S  
 If Crawl Space, Vapor barrier: Present \_\_\_ Needed \_\_\_ Ventilation: Yes \_\_\_ No \_\_\_ Vents are closed \_\_\_  
 Girders: Steel  Wood \_\_\_ % visible 100 Columns(2) Steel  Wood \_\_\_ % \_\_\_ Condition S  
 Joists  / Trusses \_\_\_ % visible 100 2x 10 Wood  Metal \_\_\_ Condition S  
 Basement/ crawl moisture: Fresh  Old stains \_\_\_ Efflorescence \_\_\_ On: Walls \_\_\_ Floors  Ceiling \_\_\_  
 Basement/crawl drainage: Sump pump: Yes  No \_\_\_ operates: Yes  No \_\_\_ Floor drain: Yes  No \_\_\_  
 The basement has been finished and the walls, ceiling and floor could not be examined without removing materials. Thus, no judgment is being made about the conditions present here: \_\_\_  
 COMMENT TYP CRACK BACK LEFT CORNER,
